INFORMATION NOTE

Damage to pipes connected to the main primary system of EDF reactors caused by stress corrosion

Date : 20 January 2022

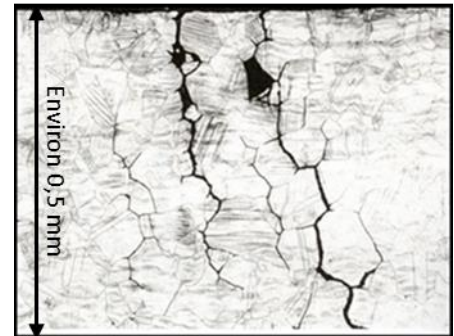
Stress corrosion Cracking (SCC) is a fairly frequent phenomenon in industry in general (excluding the nuclear industry), which is characterized by cracking in a material in contact with a chemical environment. Stress corrosion cracking is generally caused by a combination of mechanical stresses and an aggressive environment affecting **sensitive material**. This damage initiates one or several cracks, which then spread within the material, as shown in the figure opposite illustrating SCC cracks on stainless steel in contact with the primary coolant.
